THERMOGRAPHY REPORT

ELECTRICAL

Thermographic inspection at: NZ site
Inspected by: David Lambert
Inspection date: 21.02.2022

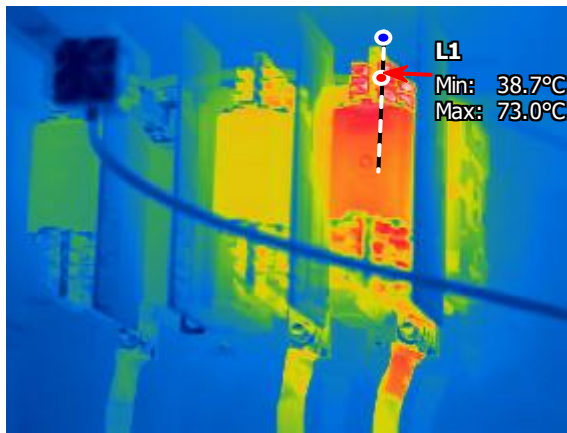
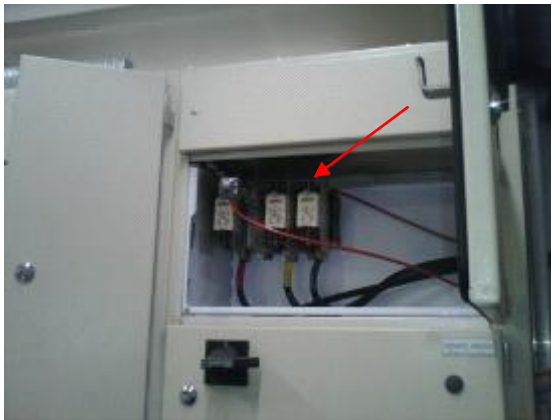
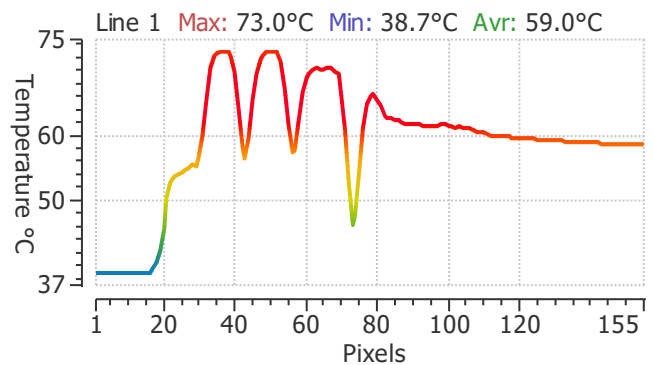
- The DB13 MCC isolator blue phase fuse connection is overheating.

Emissivity	0.96
Line 1 Max	73.0°C
Date /camera	21.02.2022

Severity: "B" Developed Overheating, Attend to at first Opportunity.

The DB13 MCC isolator blue phase fuse connection is overheating. The connected load is 87 amperes and 31 degrees above AV.

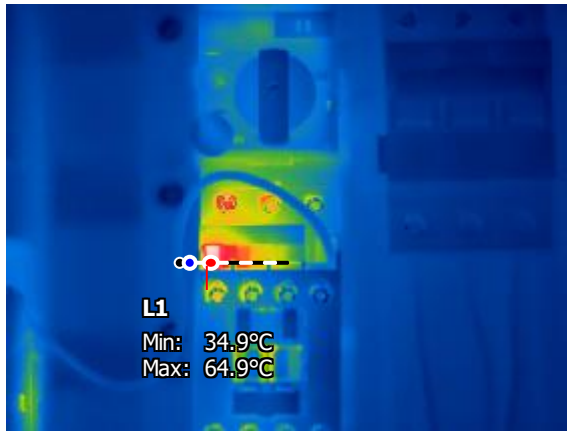
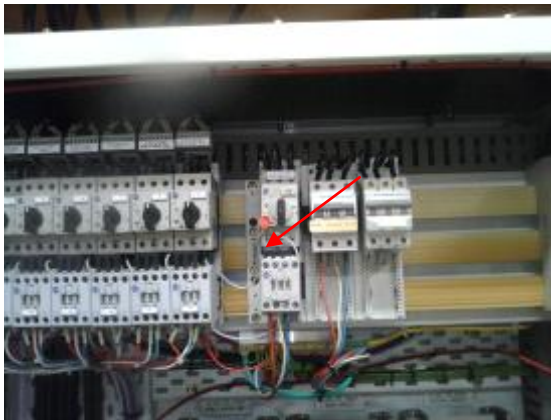
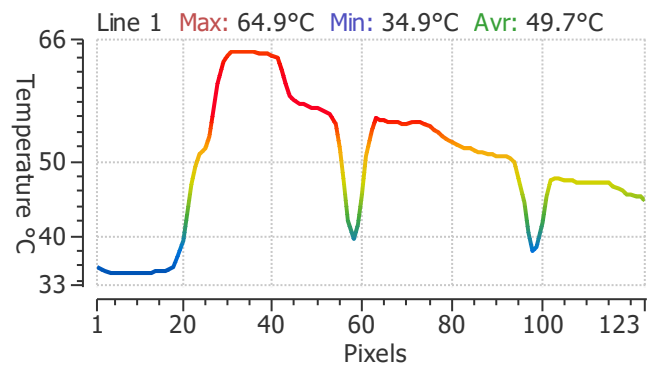
Emissivity	0.96
Line 1 Max	64.9°C
Date /camera	21.02.2022

Severity: "C" Second Stage Overheating, Schedule when possible.

The DB1 switchboard Cabinet; pump motor-overload red phase connection is overheating. The connected load is 7 amperes and 22 degrees above AV.

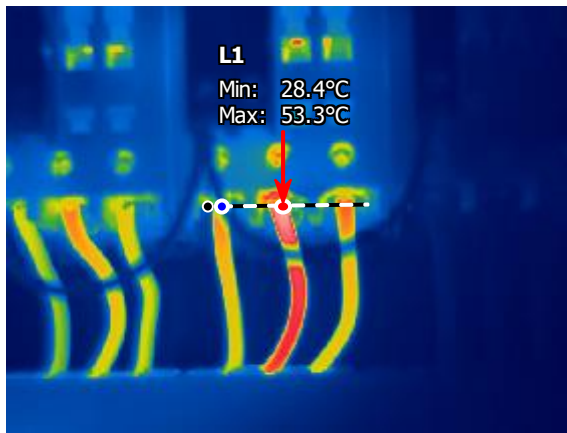
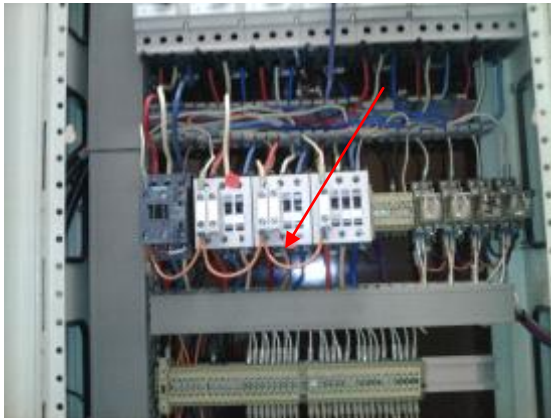
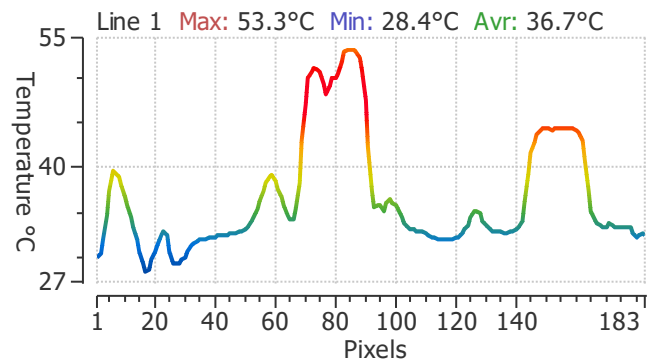
Emissivity	0.95
Line 1 Max	53.3°C
Date /camera	21.02.2022

Severity: "C" Second Stage Overheating, Schedule when possible.

The DB3, C3 contactor white phase cable termination is overheating. The connected load is 25 amperes and 13 degrees above AV.

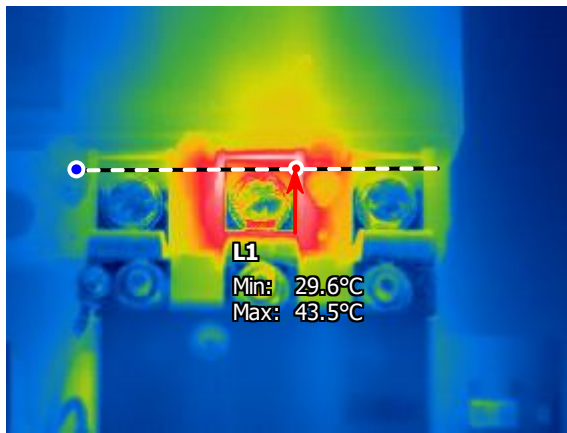
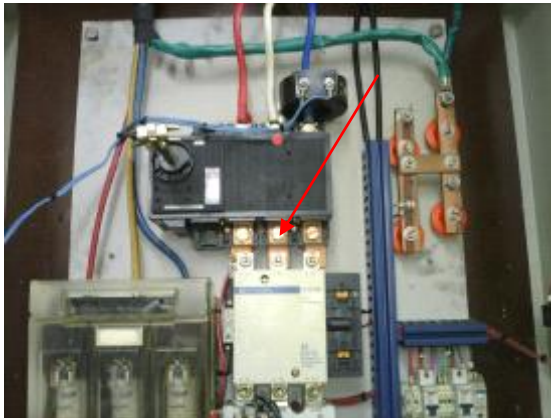
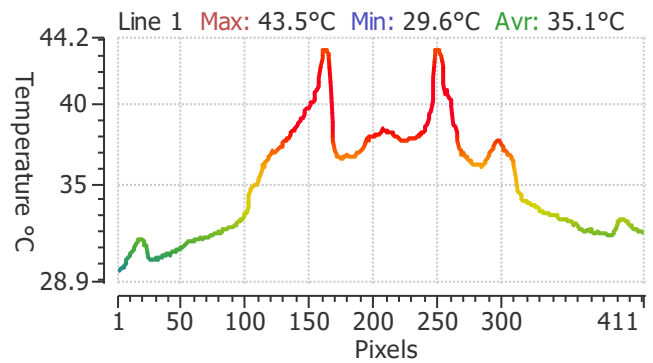
Emissivity	0.95
Line 1 Max	43.5°C
Date /camera	21.02.2022

Severity: "C" Second Stage Overheating, Schedule when possible.

Jogger control cabinet, the isolator white phase connection is overheating. The connected load is 26 amperes and 12 degrees above AV.

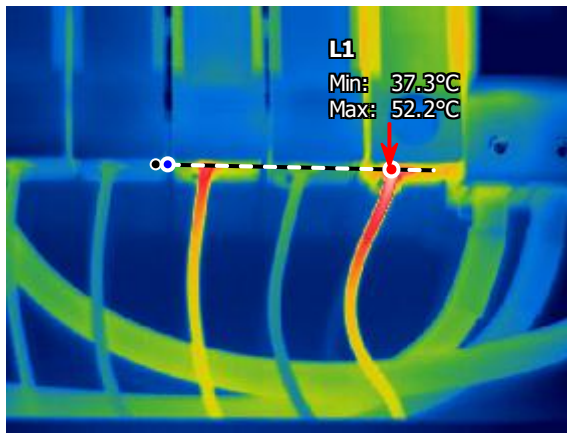
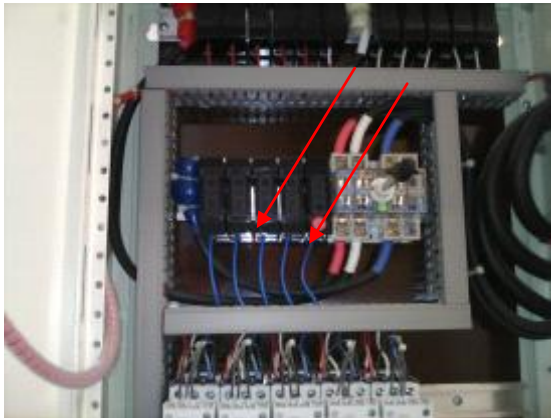
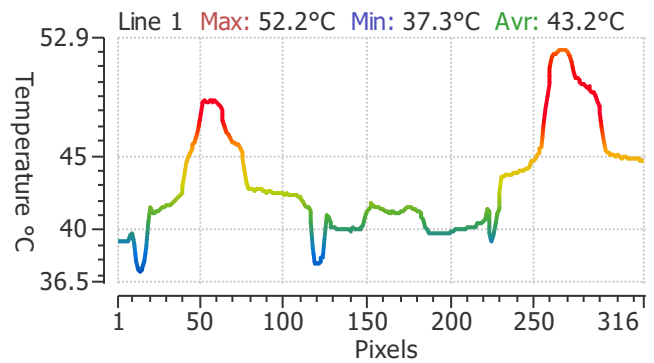
Emissivity	0.95
Line 1 Max	52.2°C
Date /camera	21.02.2022

Severity: "C" Second Stage Overheating, Schedule when possible.

The DB7 cabinet, Distribution board blue phase way 5 fuse cable termination is overheating. The connected load is 16 amperes and 11 degrees above AV.

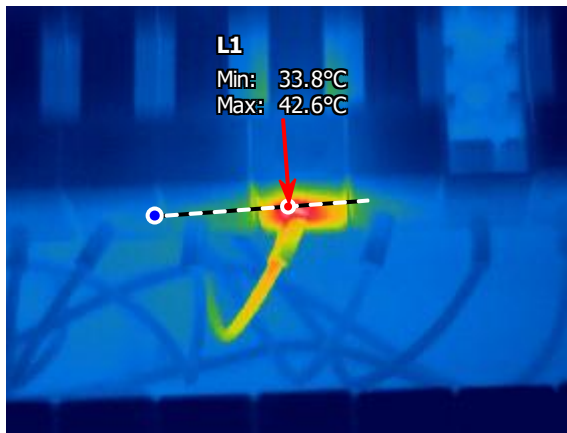
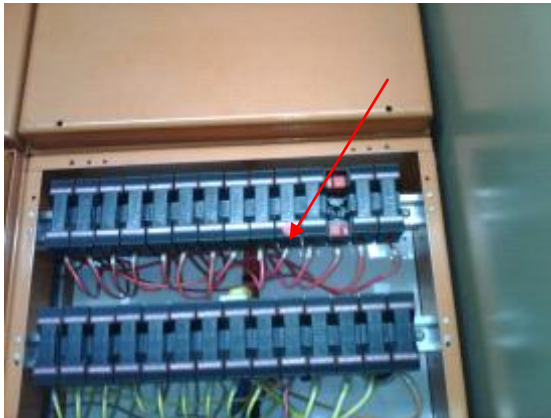
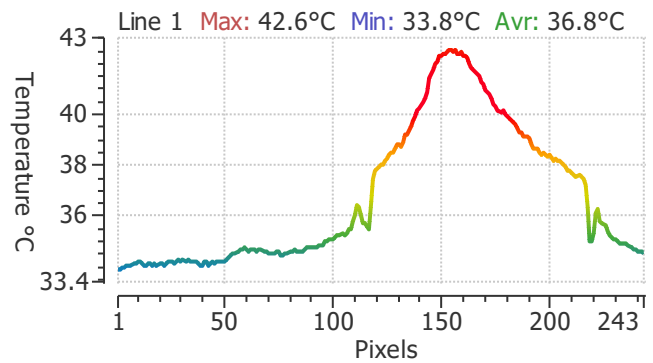
Emissivity	0.95
Line 1 Max	42.6°C
Date /camera	21.02.2022

Severity: "C" Second Stage Overheating, Schedule when possible.

The DB2, Distribution board red phase way 10 cable termination is overheating. The connected load is 2.6 amperes and 11 degrees above AV.

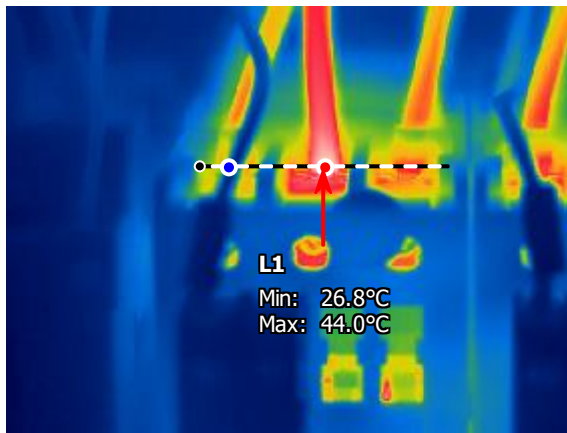
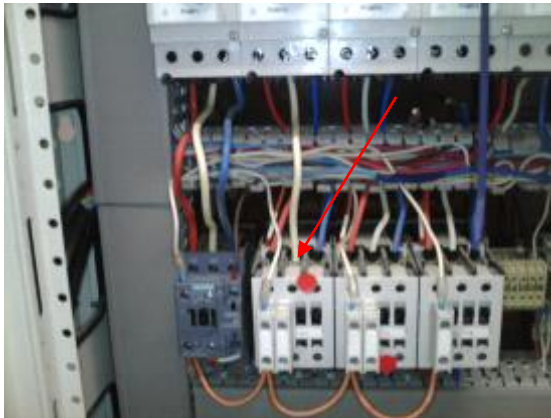
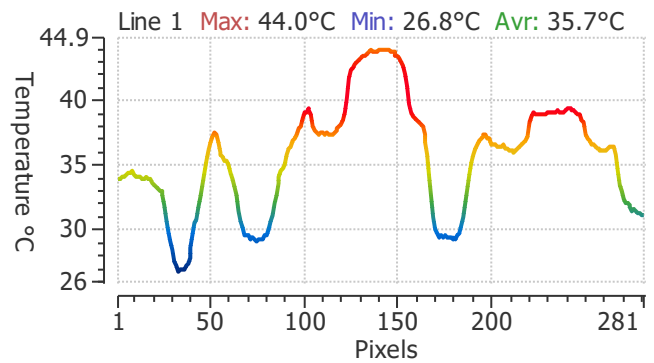
Emissivity	0.95
Line 1 Max	44.0°C
Date /camera	21.02.2022

Severity: "C" Second Stage Overheating, Schedule when possible.

The DB5, contactor white phase cable termination is overheating. The connected load is 26 amperes and 10 degrees above AV.

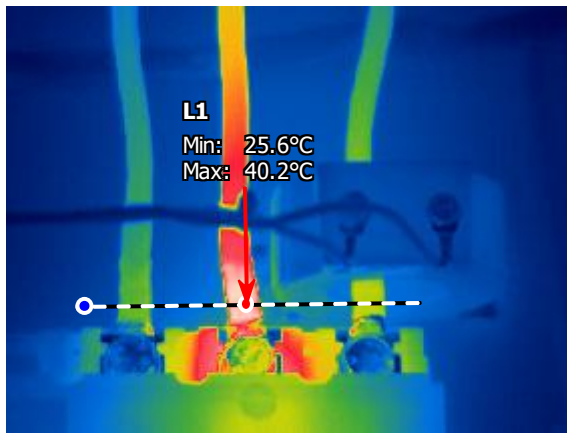
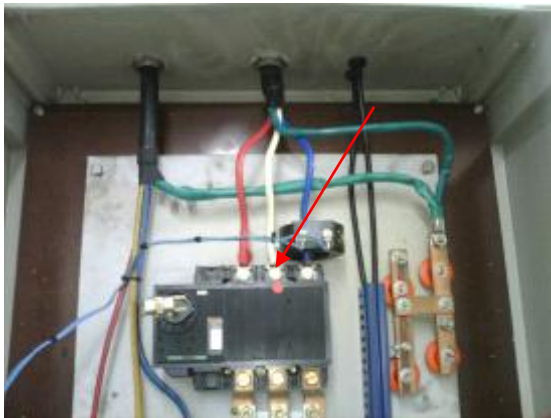
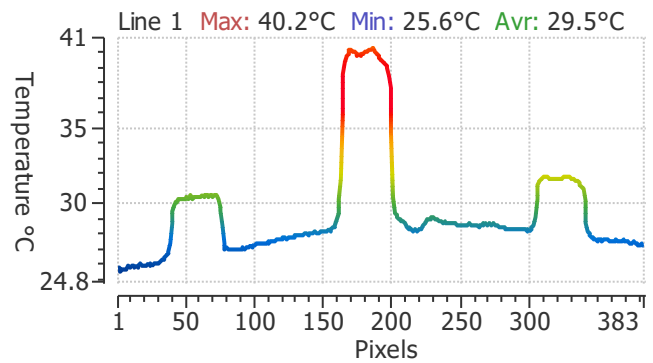
Emissivity	0.95
Line 1 Max	40.2°C
Date /camera	21.02.2022

Severity: "C" Second Stage Overheating, Schedule when possible.

The DB4, the isolator white phase cable termination is overheating. The connected load is 26 amperes and 10 degrees above AV.

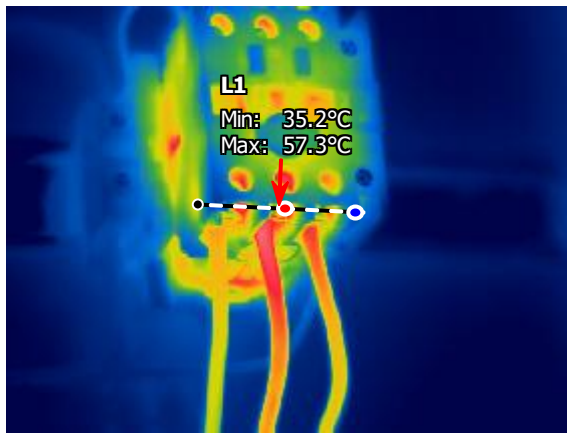
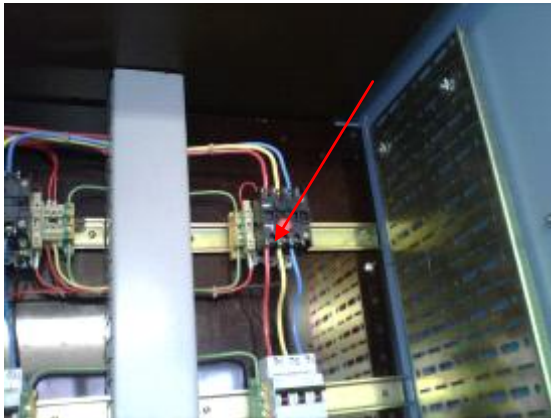
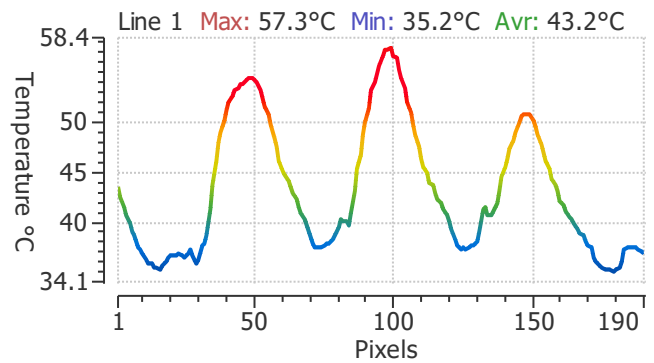
- The DB3 switch room, the power factor bank #5 contactor white phase cable termination is overheating.

Emissivity	0.95
Line 1 Max	57.3°C
Date /camera	21.02.2022

Severity: "D" Next Scheduled Maintenance.

The DB3, the power factor bank #5 contactor white phase cable termination is overheating. The connected load is 20 amperes and 9 degrees above AV.
